RICHARD L. MEEHAN

Re: Dairi Prima Minerals (DPM) Mine site risks and Tailings disposal safety.

Summary: Based on information available, and without a site visit, I provide comment on tailings dam stability risks associated with the Dairi Prima Minerals (DPM) mine in Dairi Regency, North Sumatra.

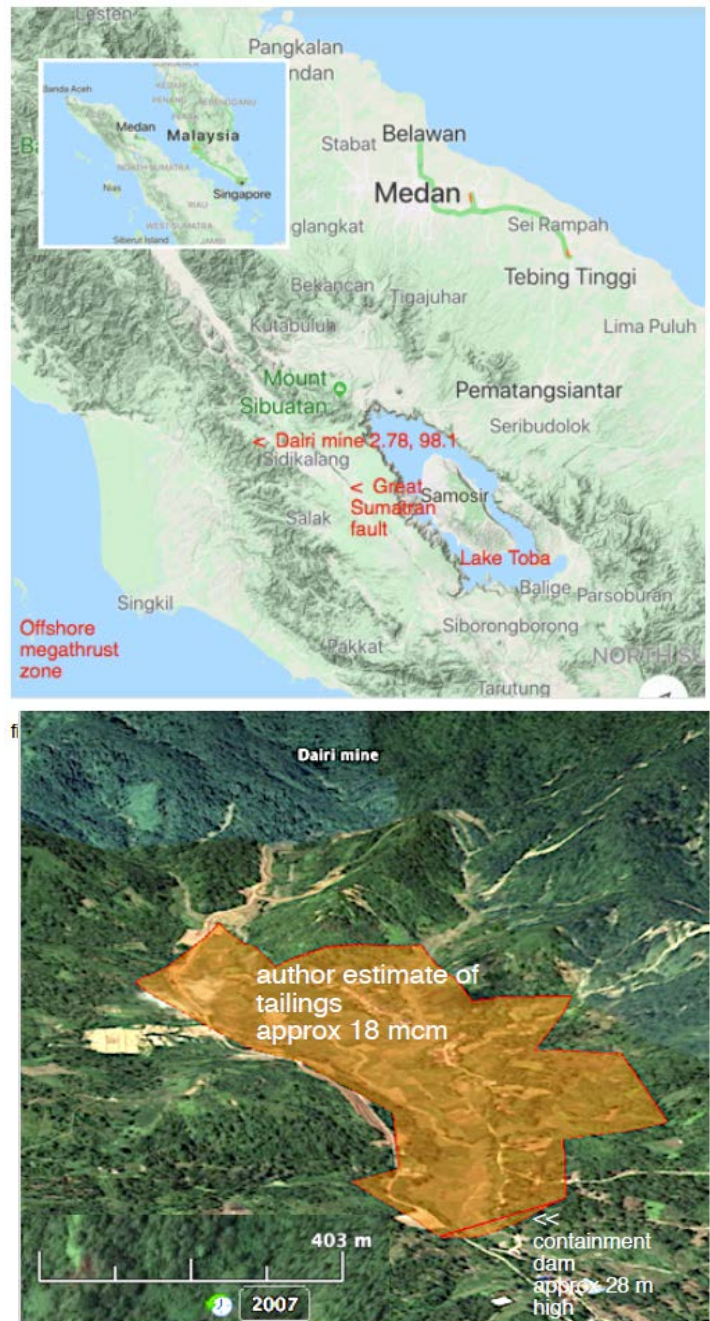
Figure 2. View of author's estimate of tailings

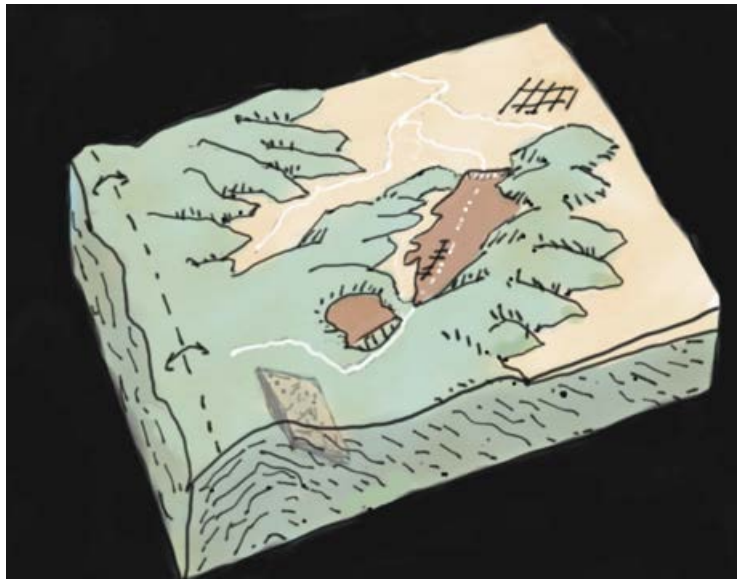
Of special importance are the characteristics of foundation in tailings dam areas. Rocks underlying the entire project area (and containing the various ore bodies) are dominantly very old (Permo-Carboniferous) rocks, carbonaceous shale and dolomitic siltstones, which have been faulted and folding by plate convergence in the Sumatran west coast (Pale green in Figure 3a). According to Middleton 2003 the formation consists of tilted beds with an EW strike and a northerly dip of about 45 degrees with fracturing from brittle tectonic deformation. Inspection of various photos showing recent (2019) road cuts in the Sopokomil valley suggest that the sequence of dipping beds carries down northerly into the hills that flank the valley as shown in my sketch fig 3a.

Figure 3a Sketch of general geological features and reported alternate tailings dam disposal areas.

The eruption of the Toba caldera some 70k years ago flooded the region with hot ash flows (ignimbrite), generally described as the Toba Tuff (pale yellow in Figure 3a). According to Middleton (apparently based on Aldiss et al, 1983) these deposits underlie the Sopokomil valley floor, site of the proposed tailings area. These volcanic deposits are generally taken to be variably cemented ("welded") but reportedly near the surface often take the form of a light ashy deposit which are found in some stream bank deposits according to photographs which I have seen. Aldiss et al describe the shallower tuffs regionally as being air-fall, unwelded, and often fluvially

reworked. This type of rock is usually low in density, subject to disintegrative weathering, and even where welded, fractured and water-bearing. The interface between the tuff and underlying older rock, at depth unknown here, is often highly permeable and a potential zone of instability because of its water-carrying capacity. An example of such instability is presented in a paper (Gratchev et al, 2011) on the 2007 earthquake at some distance from Dairi but in similar terrain where large landslides of tuff deposits burying villages with many casualties were triggered in 2007 by a combination of earthquake and heavy rainfall.

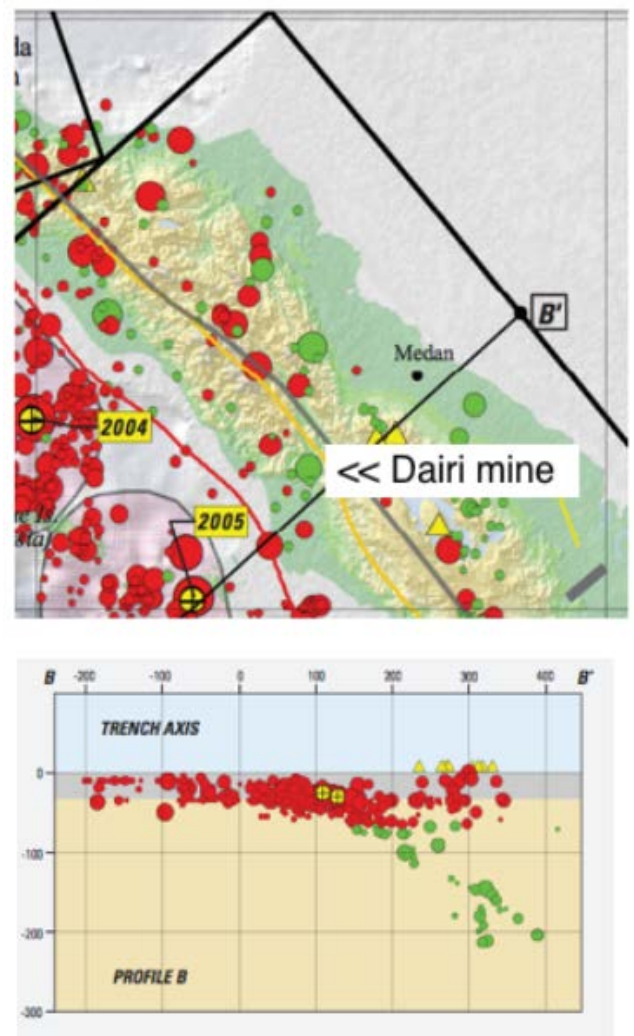
The mine is located in one of the world's most active earthquake regions, along the Sumatra subduction megathrust apparently near a triple plate junction which produced in 2004 and 2005 earthquakes of magnitude 9 and 8+ respectively (fig 3). These events rocked buildings as far away as Bangkok and produced intense regional damage including to road embankments and bridge abutments, which are similar in their behavior to tailings dams. Intensity of ground motion produced destruction of facilities at Banda Aceh, which is a comparable distance from the earthquake to the Dairi mine. Japanese investigators (see Sorenson et al., 2007) found that damage was up to about level 6, Japanese JMA scale. This damage category (6.0-6.4) produces these effects:

Figure 3. Historical earthquake (Hayes, et al., 2013)

A map and cross section showing historical earthquakes is extracted from a comprehensive summary of seismicity of the area published by the US Geological Survey (Hayes, et al., 2013). This map and many other publications provide comprehensive information on regional seismicity sufficient to evaluate earthquake risk.

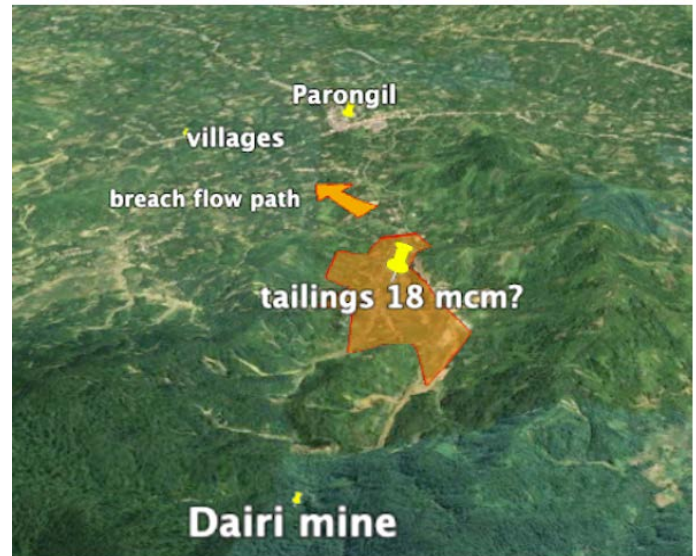
It has been suggested (Hamilton, oral communication) that the Sopokomil valley and nearby canyon may be the site of an older caldera defined by a circular ridge line which can be seen in figure 4. Such features are often underlain by rhyolite rocks associated with a rising body of extrusive lava. Such rocks are typically fractured and water-bearing.

Figure 4. Path of mud wave if a breach occurs.

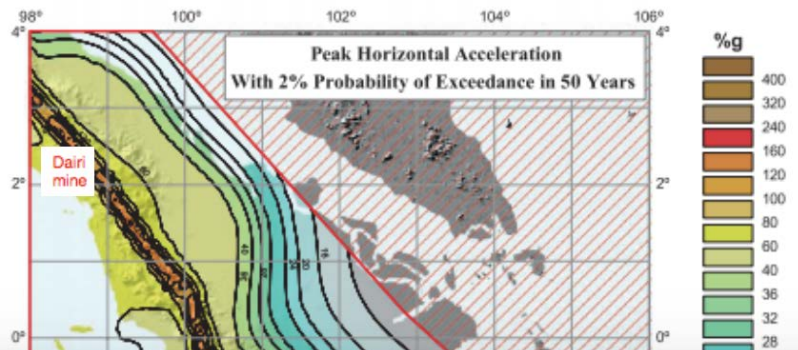
Although the offshore subduction zone mega earthquake poses a threat to long-period structures like tailings deposits, a more dangerous type of earthquake can be expected from the Great Sumatra fault which breaks ground only 15 km to the east of the Dairi site. According to Peterson et al (Ref Petersen et al., 2004) and others this fault is capable of generating earthquakes up to magnitude 7.5 to 7.9 and at this close distance are likely to produce very high ground accelerations on the order of 50-100% gravity (Figure 5).

figure 5. Tailings dam very close to Sumatra fault with likely earthquakes up to M 7.5-7.9 and ground accelerations of 100%g

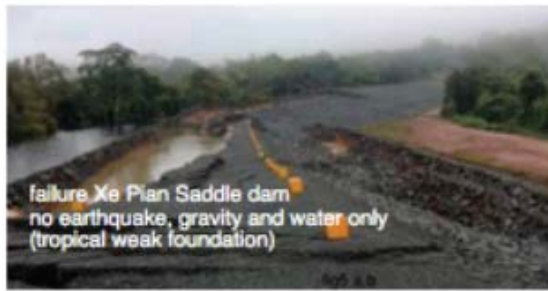
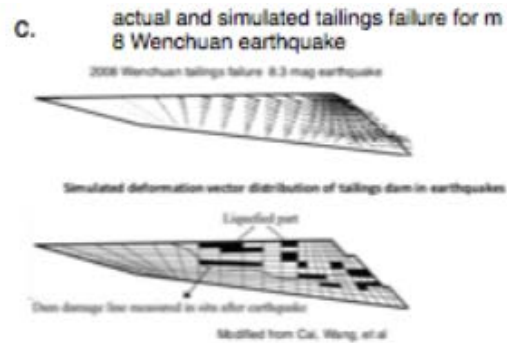
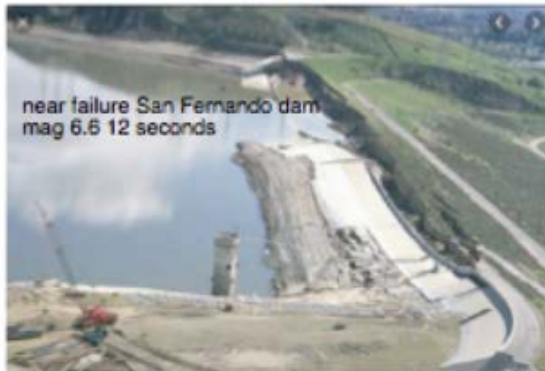
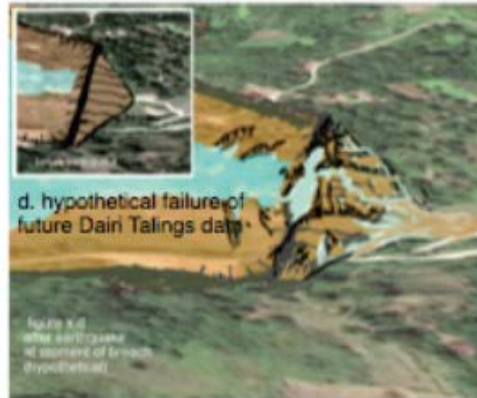
Failure of the containment for wet tailings would be most dangerous in the wet season with an abundance of water added to the containment. Cracking and sliding of the retaining structure would initially take on the appearance of the partial failure of the San Fernando dam, figure 6b (Castro et al 2003). But the San Fernando dam was subjected to only a few seconds of strong shaking. Larger earthquake from m 7.5 to 9 would produce shaking that would be much longer in duration with cracks and sliding of many meters in even robustly built dams. This would open the embankment to through flow of water and wet tailings, which would breach the Dairi containment (as in the Baldwin Hills Reservoir shown on video at <https://www.youtube.com/watch?v=c4sm7DdIMkk>) and also the Brazilian Brumadinho Mine.

figure 6. a. Failure of Xe Pian dam in Laos 2008; dam breached shortly after this photo with runoff of 500 mcm water flowing 100 km and obliterating 6 villages. No earthquake here, but poorly built dam founded on typical weak leaky tropical soils made dam unable to survive filling of the reservoir b. Near failure of the San Fernando dam in California in a short m 6.6 earthquake. Another few seconds of shaking would have breached this dam with a great death toll. c Analysis by Cai, Wang, et al of a tailings dam in the 2008 Wenchuan earthquake shows that the dam fails in a m=8 earthquake. d. Likely performance of a tailings dam at Dairi mine during a very strong earthquakes, probably from the Great Sumatran fault zone near the site.
