RICHARD L. MEEHAN

June 16, 2023

Re: Dairi Prima Minerals (DPM) Mine site risks and Tailings disposal safety.
Review of Dairi 2022 EIA Addendum.

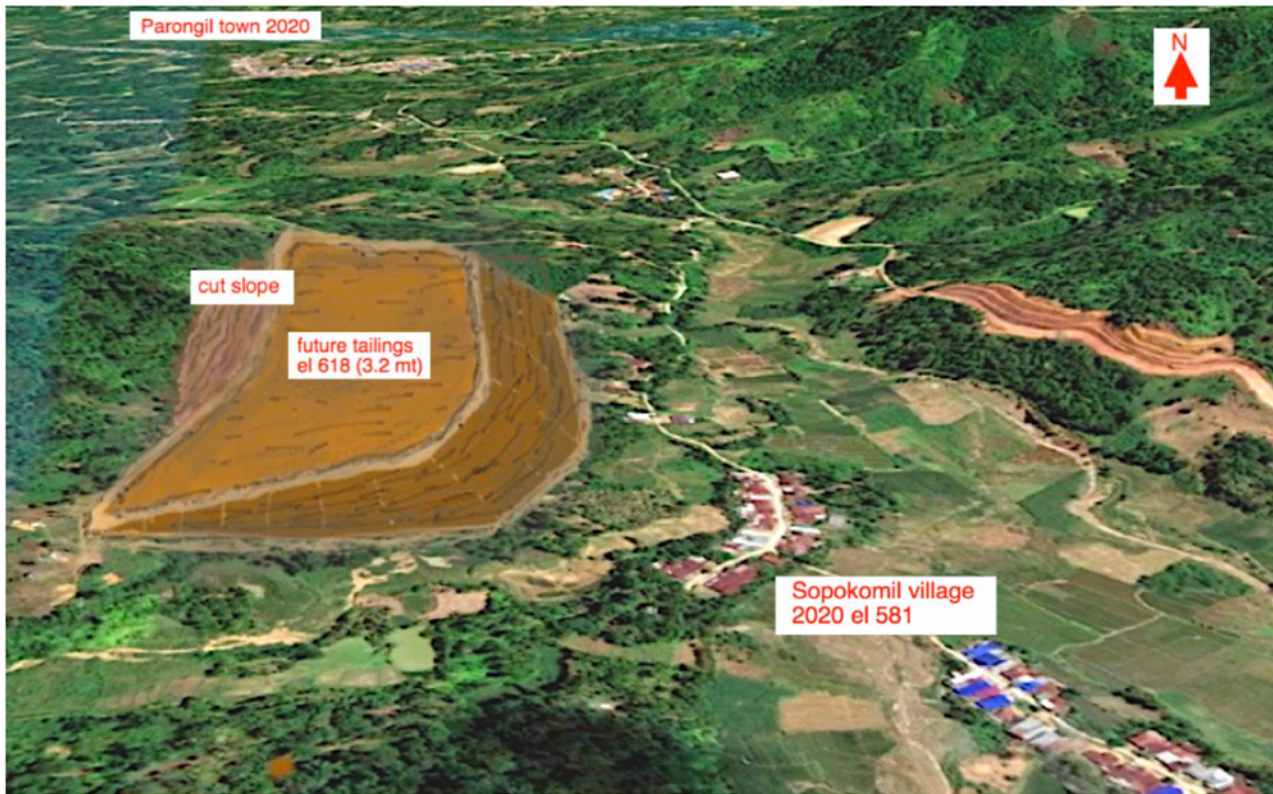
Figure 1. Planned configuration of TSF, 3.2 million tons at elevation 618. TSF configuration (brown color) from EIA Addendum fig 2.22 sketched onto Google Earth image by the author. Breach of the tailings dam above the Sopokomil village is likely in a strong earthquake because the ground between and beneath the village and the TSF and the dam foundation is unstable volcanic ash soils subject to liquefaction.

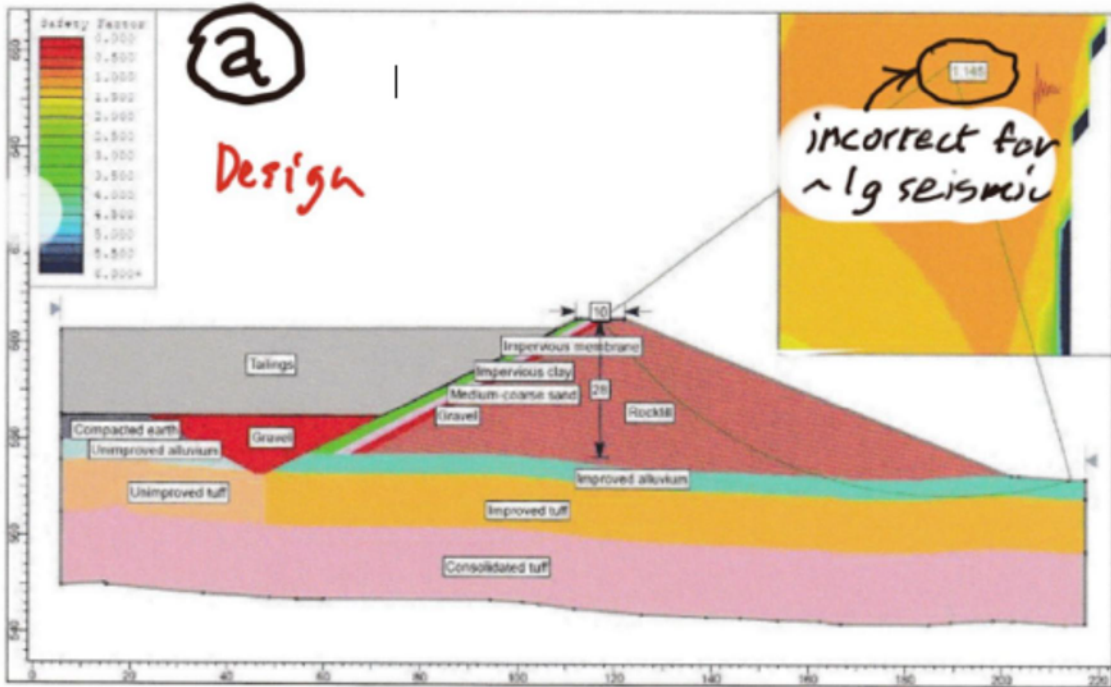
Gambar 2.47 Gambar Perhitungan Nilai FoS Disesuaikan Dengan Kondisi Akhir TSF

This amplification in the material overlaying the bedrock would invalidate the undocumented seismic stability analysis provided by DPM in EIA Figure 2.47. That figure concludes that the “factor of safety” (which must be more than 1.0), will be 1.03 apparently for Prof Natawidjaja's "maximum credible" earthquake of .489g. However, if site amplification is taken into consideration, the “factor of safety” for DPM’s proposed TSF would be below 1.0, down to even 0.7 (meaning the dam would be considered highly unsafe). Even lower factors of safety would occur if the dam and tailings quantities were higher than that specified in the EIA. Emerman(2023) has conducted a study of surface storage requirements for the TSF and concluded that the EIA significantly underestimates the volume and height of the required TSF. If this proves to be the case, even lower margins of safety will result.

In addition to lowering the factor of safety, failure to consider amplification also results in an incorrect failure configuration such as the one shown on EIA figure 2.47, part A. Amplified ground motion or loss of foundation bearing capacity due to liquefaction would instead flatten the failure surface in a way that causes sinking of the dam as suggested in the sketch, part B herewith.

DPM now claims, without any stated basis, (figure 2.47, extract attached) that unstable ash soil does not extend to depths greater than 16 meters. It may extend deeper, but even 16 m depth, over an area of roughly 100 x 500 m represents 800,000 cubic meters (more than a million tons) of soft volcanic soil that would need to be “improved”. This is more than the volume of the retaining rock fill dam. Removal, replacement, compaction or other form of stabilization of this amount of soil would be in an enormous task and unlikely to be implemented because it would make the project economically infeasible. There is not even any suggestion as to whether this ash *can* be improved by normal recompressive efforts, addition of chemicals, etc. In fact, the EIA Addendum elsewhere indicates that the ash is not suitable for important construction except for road fill because it is "soft volcanic eruption".

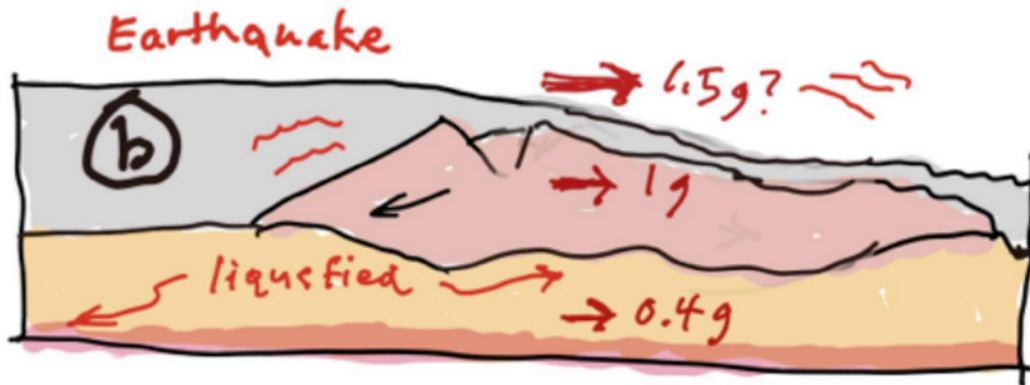
These soft loose volcanic ash beds 50 or more meters deep would be present above the bedrock and below the dam embankment. They would change the character of seismic ground motion specified by Prof Natawidjaja as waves of energy move upwards from bedrock into the dam. The dam would see longer periods of seismic excitation and higher, more dangerous G forces. In many other sites with similar non-bedrock foundations, ground motions 0.5g at bedrock level (see b, above) would generate ground motions of close to 1g at the dam level. Ground motion could be amplified to exceed even 1g. This amplification phenomenon has been known and accepted by engineers since the late 1950s
